# Manhole Inspection Summary

Manhole # S37AA1036MH

**Location** Address: **3400 OLD YORK RD**

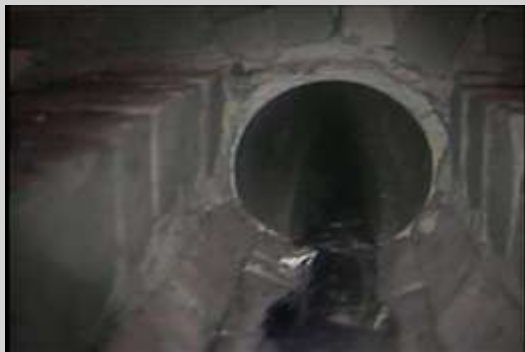
### 8 in. Circular Gravity Sewer Pipe Out @ 12 O'Clock

Pipe Material: **Clay** ☐ Pipe Lined

Invert Depth: **8.00** (ft.) Flow Characteristics: **Slow**

Deposits: ☒ None ☐ Mud ☐ Sludge ☐ Debris ☐ Grease

Infiltration: **None** Pipe Seal Cond: **Unknown**

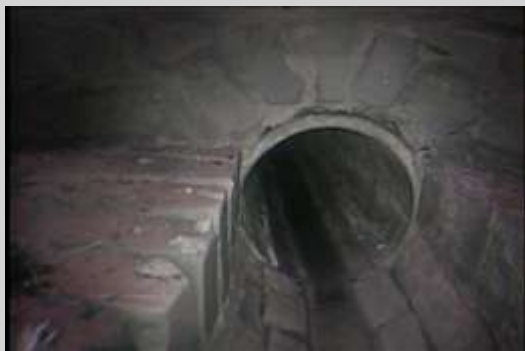
### 8 in. Circular Gravity Sewer Pipe In @ 4 O'Clock

Pipe Material: **Clay** ☐ Pipe Lined

Infiltration: **None** Pipe Seal Cond: **Unknown**
